Service Bulletin AQ05

September 2008

Pigtail Swelling.

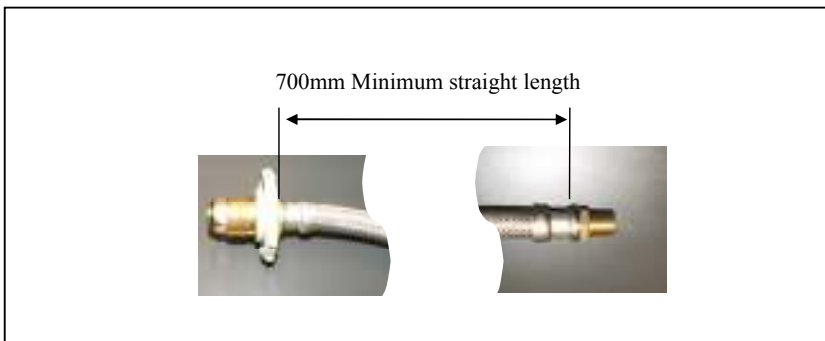
Fig 'A'

Where swelling has occurred the pigtail will shorten in length.

We suggest that if you have any concerns in relation to change in length or swelling you should measure the hose length as in fig A [points a to b] and if the hose is less than 700mm in length we suggest you replace the hose.

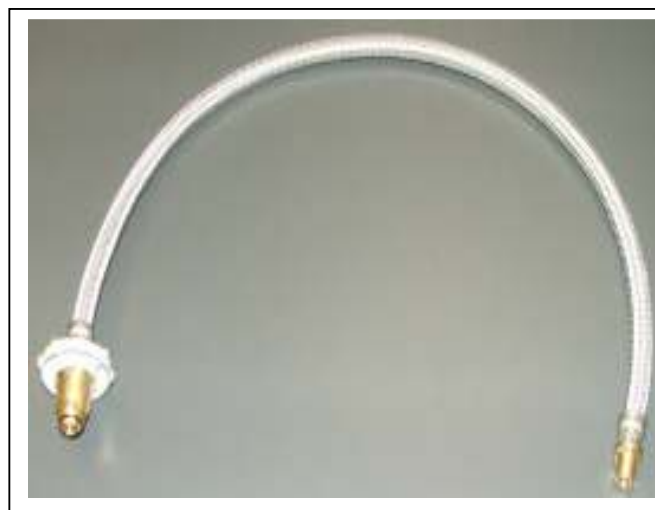
General View of
FPT 1413

In recent months Aquaknect have been made aware of swelling affecting a small number of FPT1413 Flexible Pigtails while in service.

Your local agent (Aber in New Zealand) will replace the hose free of charge and reimburse reasonable labour costs if the hose is found to be outside of the parameters indicated above.
