1 January 1998 to 31 December 2000

summary of reported electrical and gas accidents

Energy Safety Service

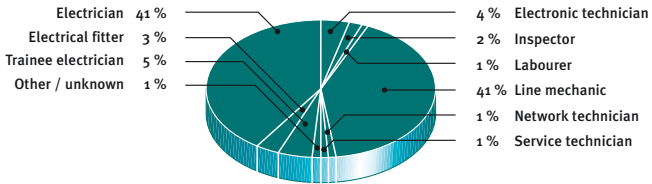
Notifiable Electrical Accidents to Electrical Workers 1993 - 2000 Graph 3

by worker category

Electrical Workers (Graphs 2, 3 and 4)

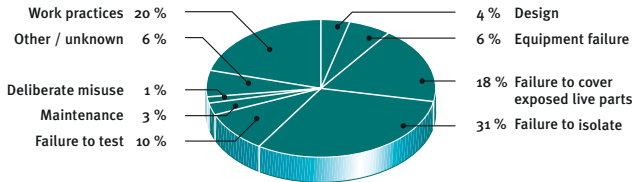
Notifiable Electrical Accidents to Electrical Workers 1993 - 2000 Graph 4

by causal factor

- The immediate causes of up to 80% of accidents to electrical workers were unsafe work practices, failure to test before work is undertaken, failure to isolate live lines, and failure to use adequate barriers, or cover-up live parts. About one third of accidents involving line mechanics were due to not following work practices and a quarter were due to failure to cover exposed live parts. For electricians, about half of the accidents were due to failure to isolate, and one seventh due to failure to cover exposed live parts. Graph 4 shows the causal factors for notifiable electrical accidents to electrical workers from 1993 to 2000.

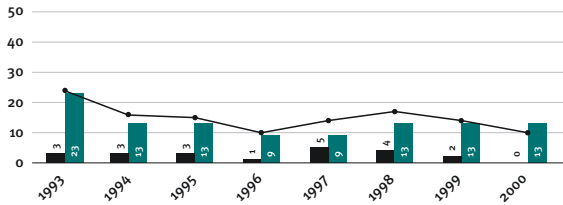
Notifiable Electrical Accidents – to the General Public 1993 - 2000 **Graph 8**

■ Fatalities ● Notifiable accidents
■ Injuries

General Public (Graphs 8 and 9)

- Over the eight years of data collection, the number of electrical injuries to the general public indicates a small decrease. This is due to a higher number of injuries in 1993. The last seven years data shows no statistical change in the level of injury to the general public. Graph 8 shows the numbers of electrical accidents, fatalities and injuries from 1993 to 2000 to the general public.
- One third of the electrical accidents to the general public were caused by a lack of maintenance of electrical appliances, wiring and fittings. Deliberate actions or the misuse of electrical appliances and fittings caused one sixth of the accidents to the general public. Graph 9 shows the causal factors for notifiable electrical accidents to the general public from 1993 to 2000.
