1 January 1998 to 31 December 2000

summary of reported electrical and gas accidents

Energy Safety Service

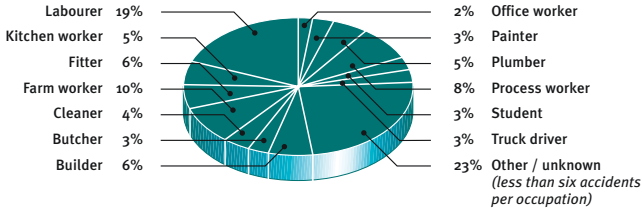
by occupation

* Workers in occupations other than electrical work

- Labourers (19%), farm workers (10%), process workers (8%), builders and fitters (6%), plumbers and kitchen workers (5% each) are the most at-risk groups. Graph 6 shows the percentages of notifiable electrical accidents to different categories of workers from 1993 to 2000.
- More than half the accidents were due to unsafe work practices, failure to isolate live electrical parts, failure to cover exposed live parts, or failure to test. About a quarter were caused by a lack of maintenance of electrical appliances and fittings. Graph 7 shows the causal factors for notifiable electrical accidents to workers in occupations other than electrical work from 1993 to 2000.

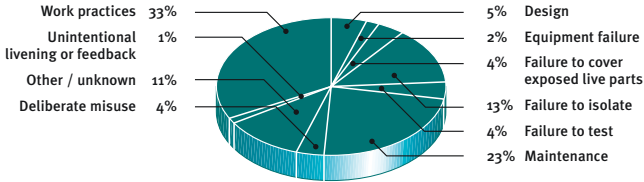
Notifiable Electrical Accidents to People In Other Occupations* 1993 - 2000 Graph 7

by causal factor

* Workers in occupations other than electrical work

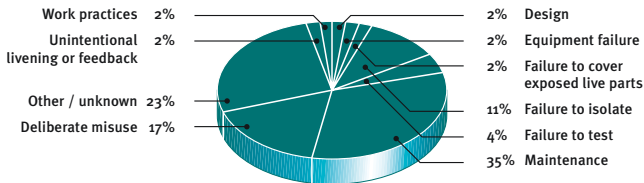
Notifiable Electrical Accidents – to the General Public 1993 - 2000 Graph 9

by causal factor

General Public (Graphs 8 and 9)

- Over the eight years of data collection, the number of electrical injuries to the general public indicates a small decrease. This is due to a higher number of injuries in 1993. The last seven years data shows no statistical change in the level of injury to the general public. Graph 8 shows the numbers of electrical accidents, fatalities and injuries from 1993 to 2000 to the general public.
- One third of the electrical accidents to the general public were caused by a lack of maintenance of electrical appliances, wiring and fittings. Deliberate actions or the misuse of electrical appliances and fittings caused one sixth of the accidents to the general public. Graph 9 shows the causal factors for notifiable electrical accidents to the general public from 1993 to 2000.

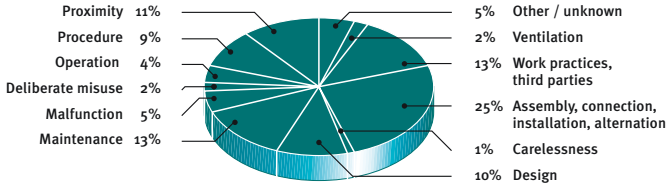
Notifiable Natural Gas Accidents 1993 - 2000 Graph 11

by causal factor

- Graph 11 shows the causal factors for notifiable natural gas accidents, fatalities and injuries from 1993 to 2000. A quarter of the natural gas accidents could have been avoided if appropriate care was taken during installation (assembly, connection and installation) of the gas system. Thirteen percent of the accidents could have been avoided by maintaining gas appliances and supply systems. The same number of accidents could have been avoided by good working practices by gas workers and other utility supply (or contract) workers.

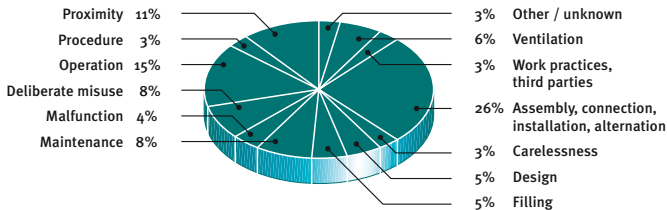
Notifiable LPG Accidents 1993 - 2000 Graph 13

by causal factor
